# SUMMARY

1234 Bay St, My Twin City, ON August 19, 2026

Report No. 1098, v.4

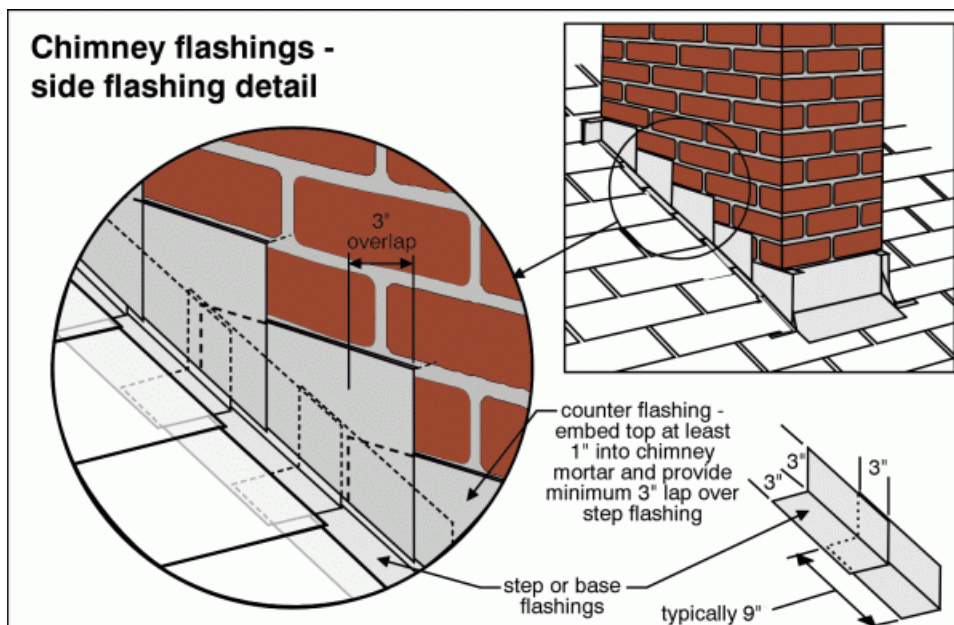
**1. Condition:** • Not let into mortar joints

**Implication(s):** Chance of water damage to structure, finishes and contents

**Task:** Have the flashing further evaluated and properly integrated/sealed at the masonry joints by a qualified roofing or masonry contractor.

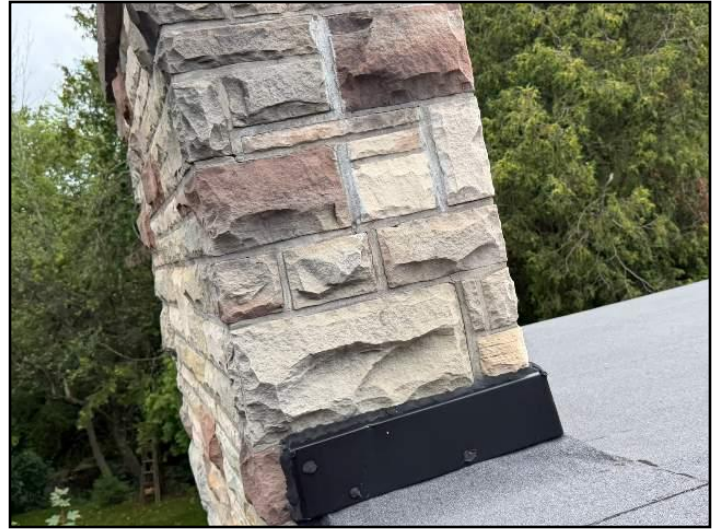
9. Not let into mortar joints

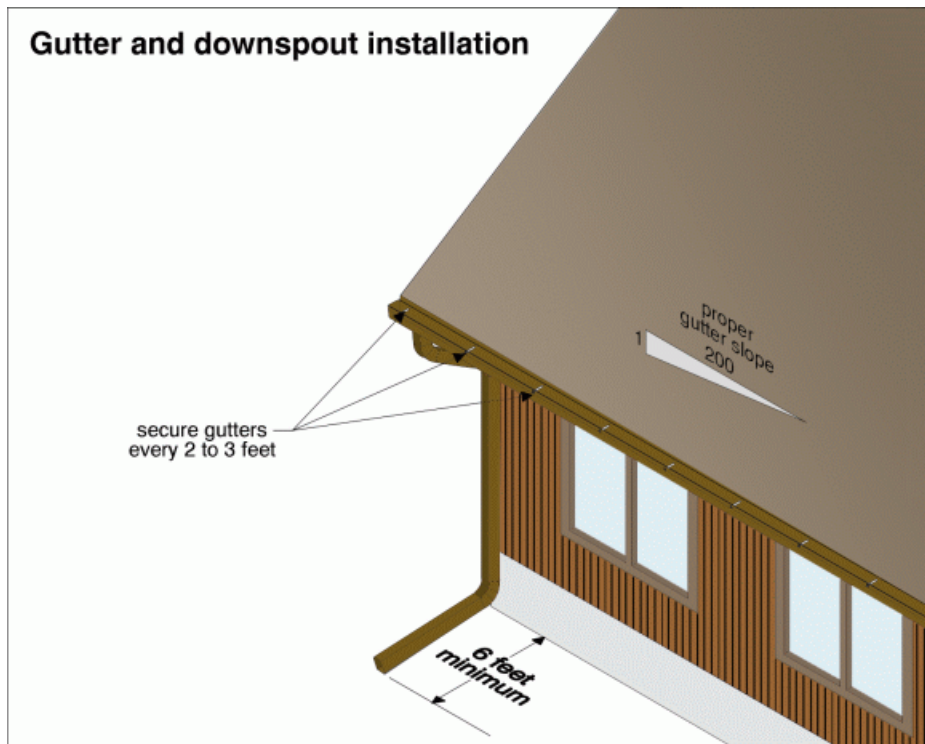
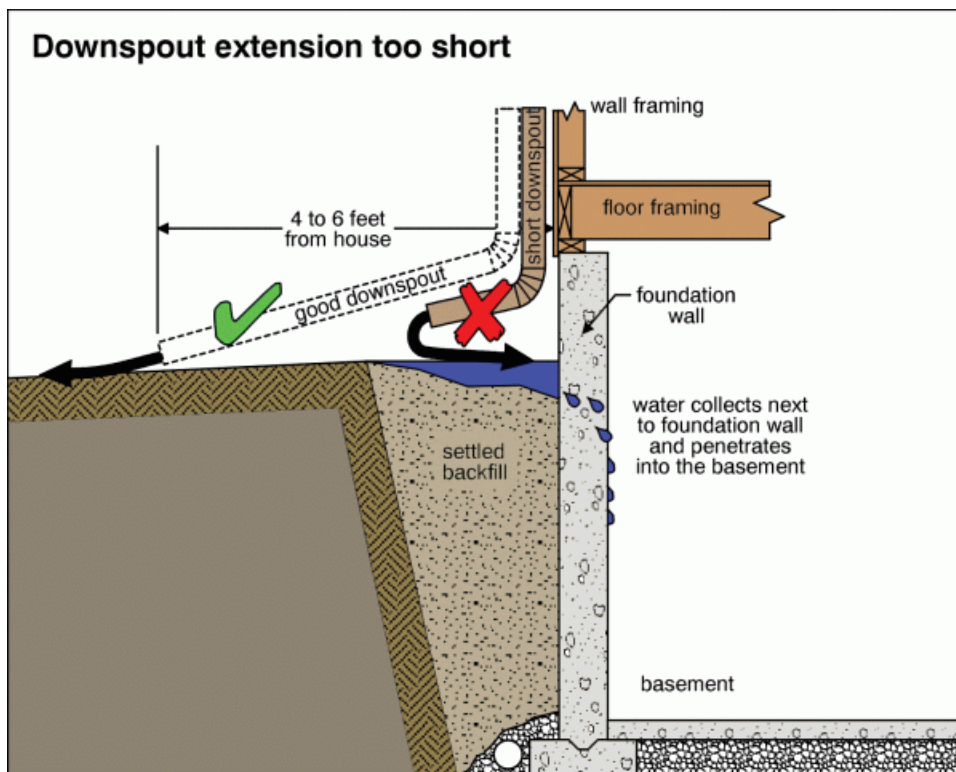
**2. Condition:** • Discharge too close to building

**Implication(s):** Chance of water damage to structure, finishes and contents

10. Discharge too close to building

**Task:** Extend downspouts to direct water away from foundation.

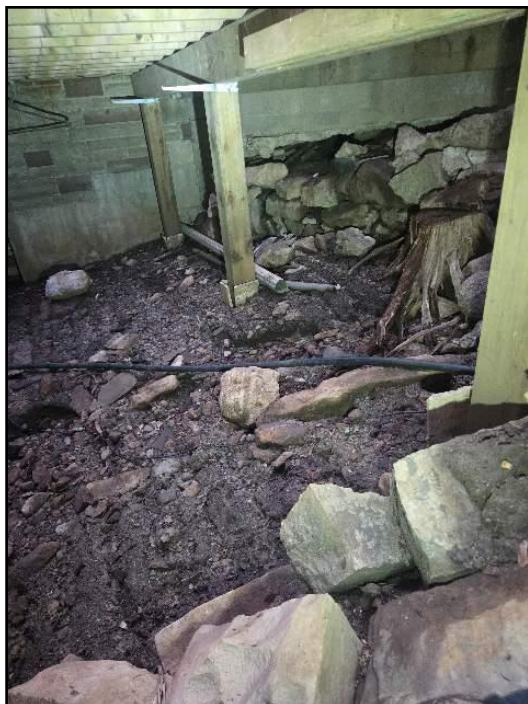
Wood deck support posts were observed in direct contact with soil, with elevated moisture noted around portions of the support structure.

**Implication(s):** Weakened structure | Chance of movement | Rot | Insect damage

11. Wood/soil contact

**Task:** Improve drainage and separate the wood posts from direct soil contact where possible. Monitor the affected areas for moisture, decay, and premature wood deterioration.

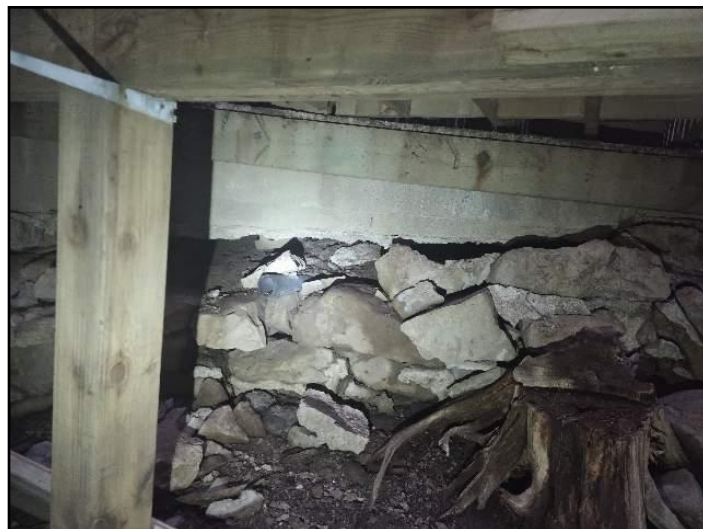
12. Wood/soil contact

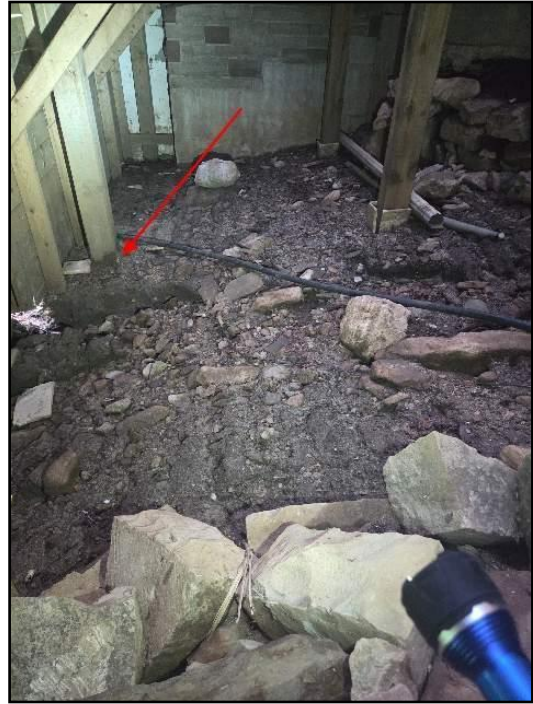
14. Wood/soil contact

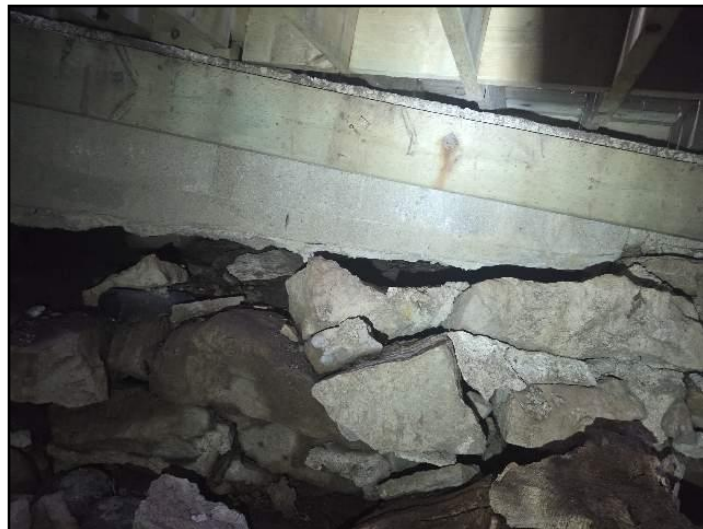
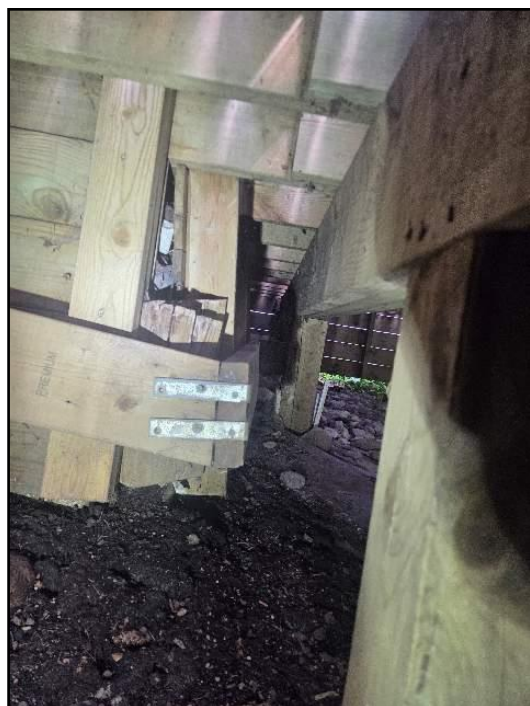
**4. Condition:** • Localized displacement and deterioration observed in the stone/concrete retaining area, with some stress noted at adjacent wood framing.

**Task:** Monitor the area for further movement and have the affected area further evaluated and repaired or stabilized as needed.

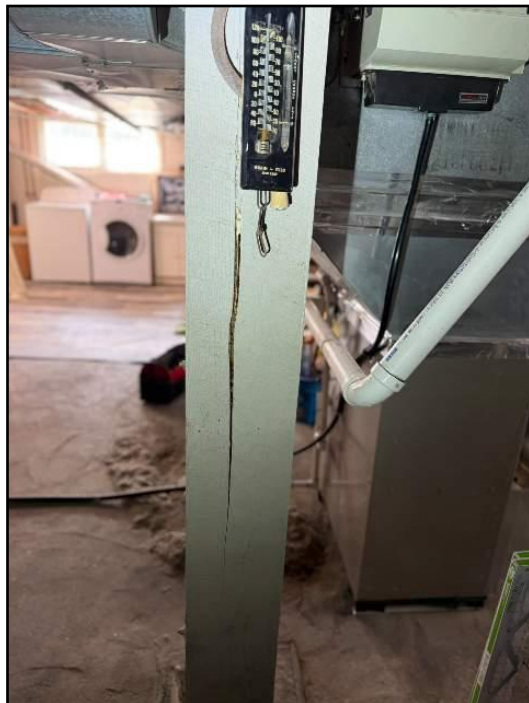
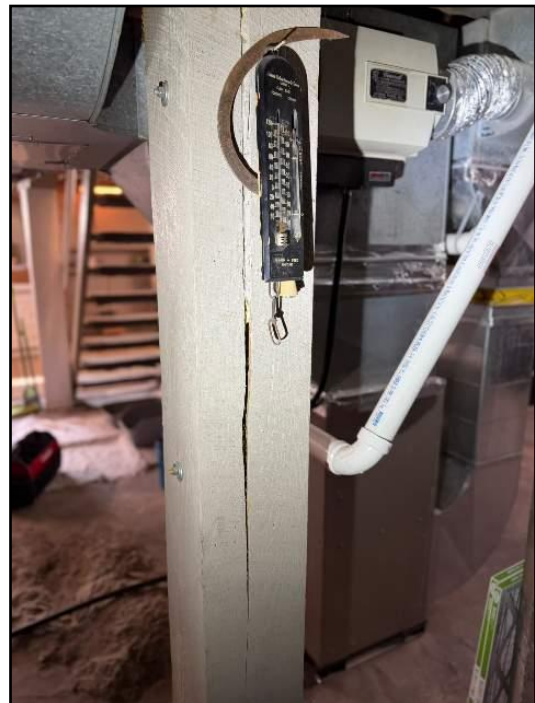
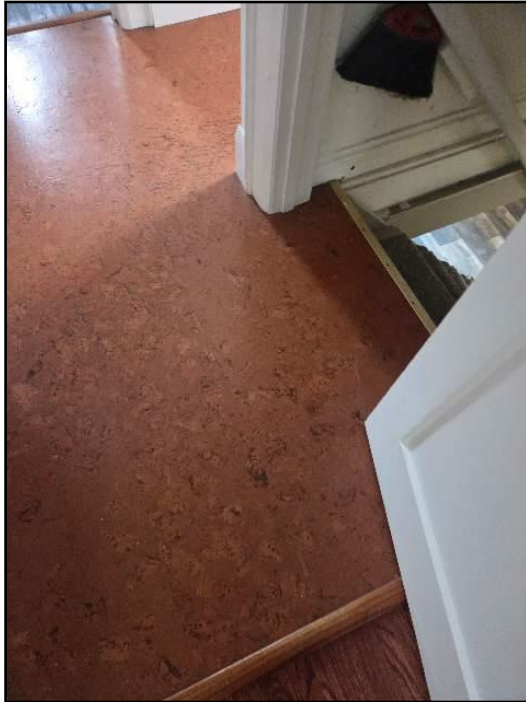
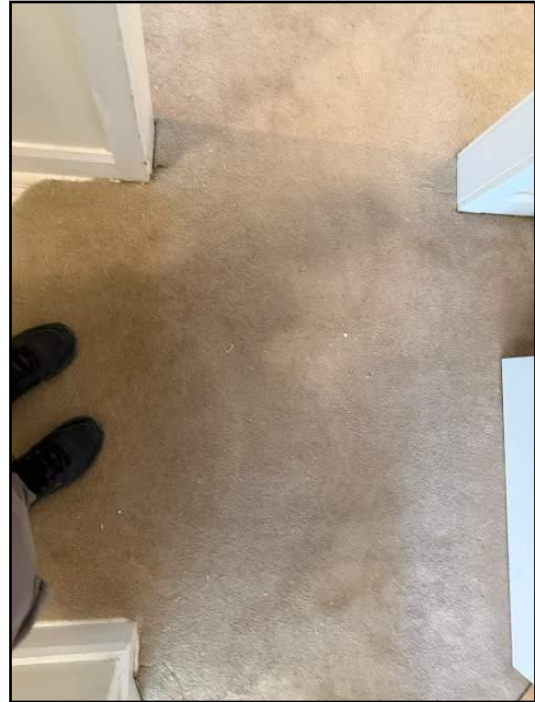
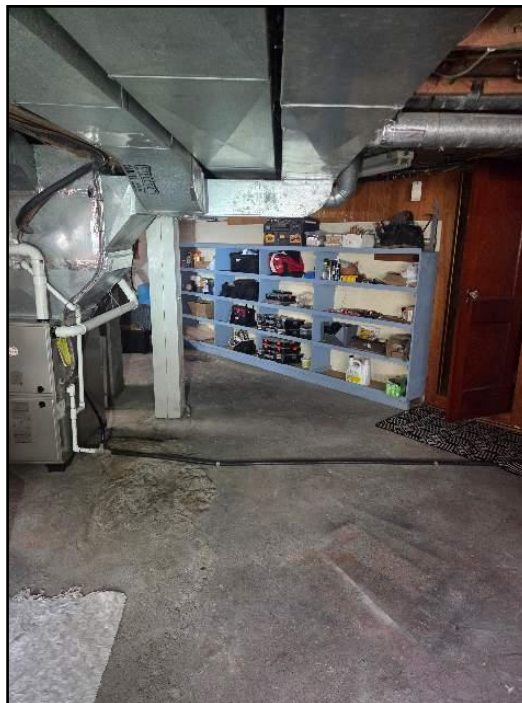
**5. Condition:** • Prior repairs

A prior repair was observed at the basement support post, where a vertical split has been secured with through-bolts. Minor floor settlement/unevenness was also observed in the area above the post.

20. Prior repairs

**Task:** Monitor the area for further movement or settlement. Have the support post and existing repair further evaluated by a qualified contractor if additional movement or deterioration is observed.

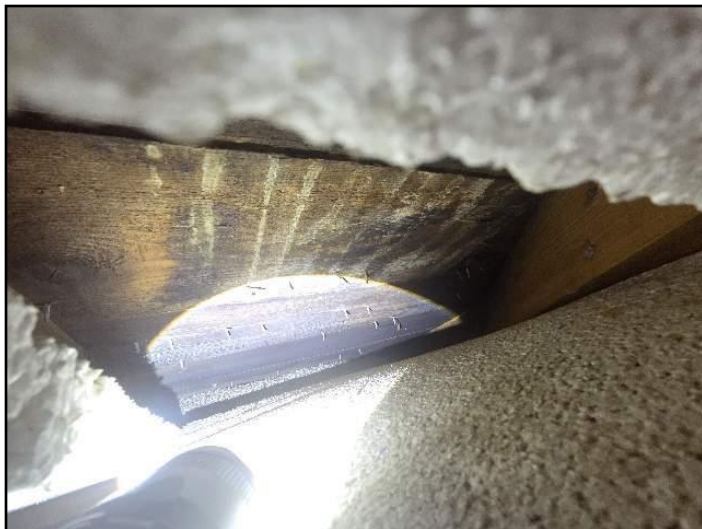
25.

**6. Condition:** • Staining and discoloration observed on portions of the attic roof framing. Portions of the framing were covered with foam insulation.

**Task:** Have the attic framing and roof area further evaluated by a qualified roofing contractor and repair as needed.

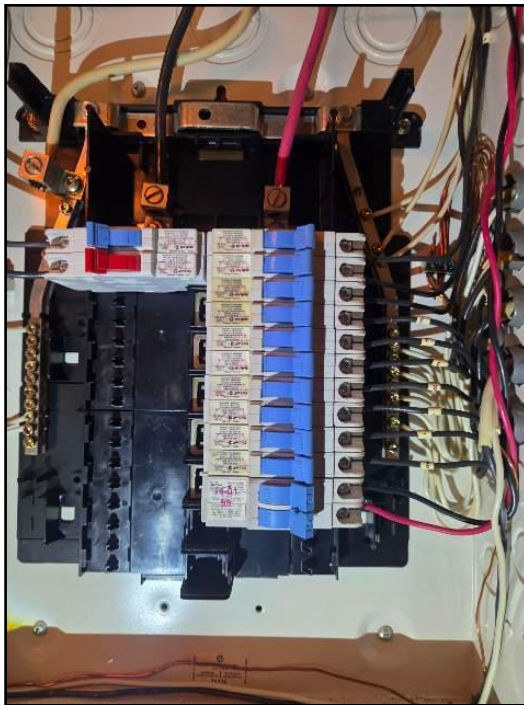
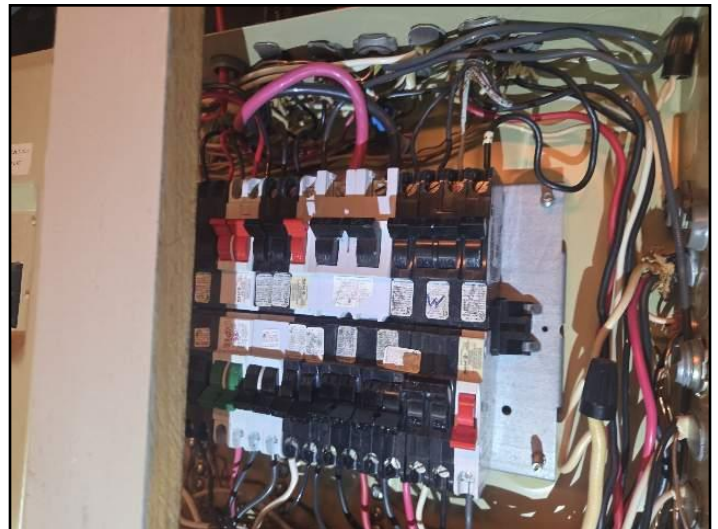
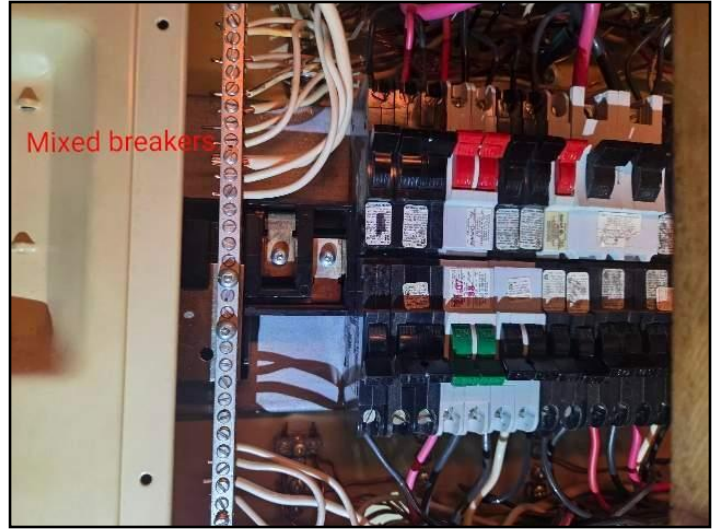
**7. Condition:** • Federal Pioneer Stab-Lok electrical panel and breakers observed.

**Implication(s):** Certain Stab-Lok circuit breakers have been subject to safety recalls due to the potential for breakers to fail to trip under fault conditions, increasing the risk of overheating or fire.

**Task:** Have the panel and breakers further evaluated by a qualified electrical contractor. Replacement of the panel should be considered based on the evaluation and condition of the equipment.

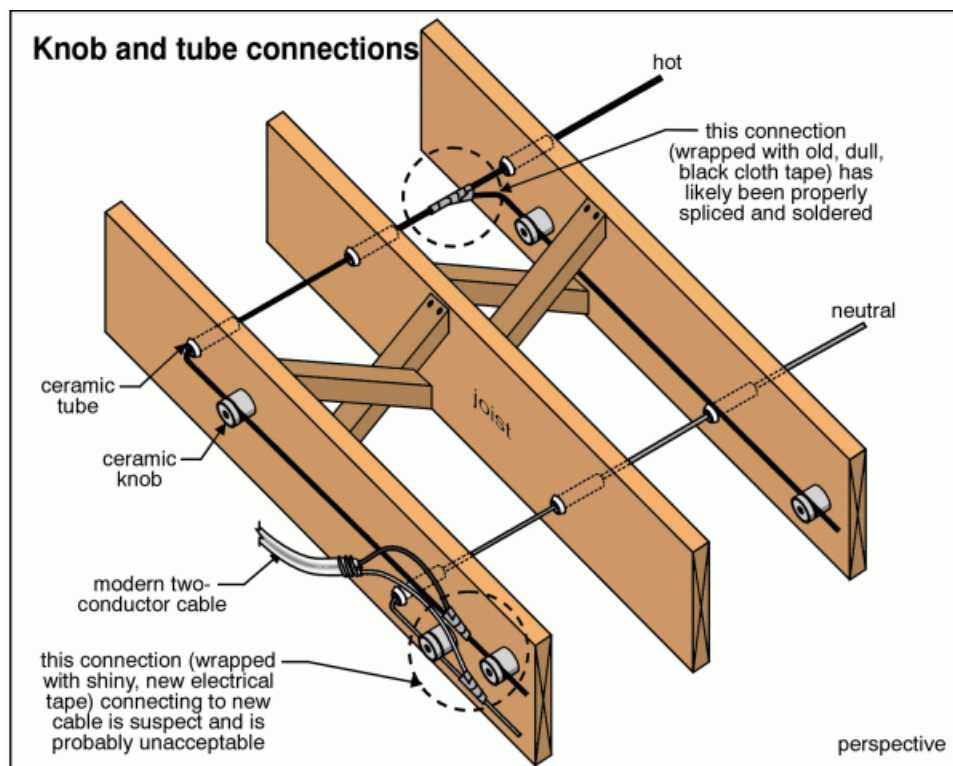
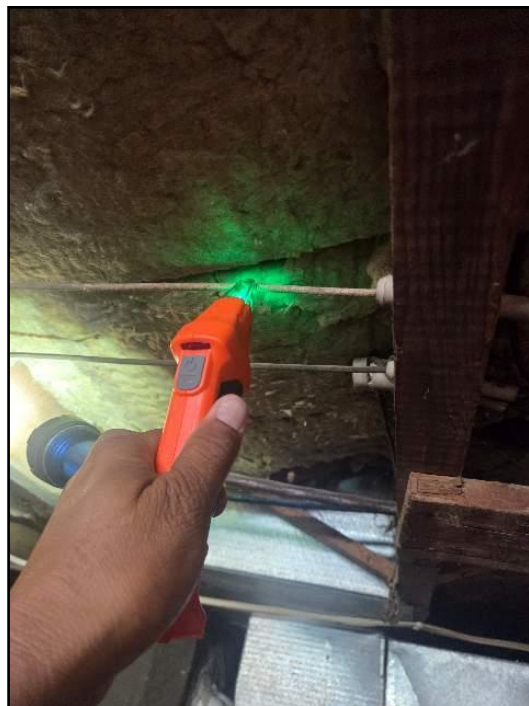
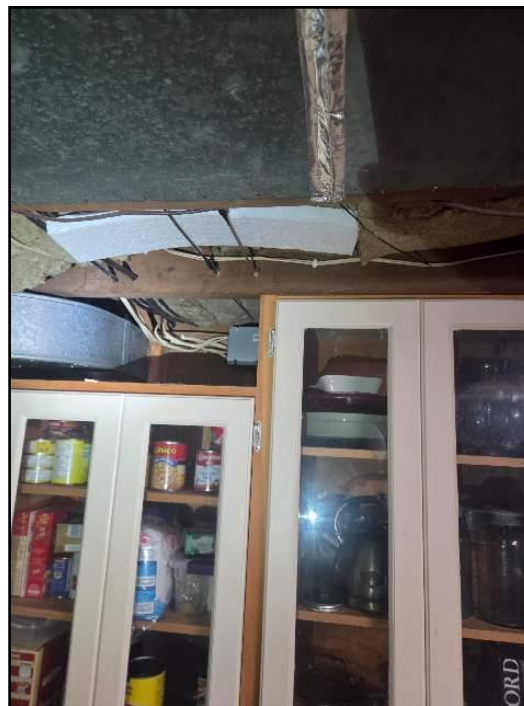
Older knob-and-tube wiring was observed in the basement. The wiring was not energized when tested at the time of inspection.

**Implication(s):** Possible electric shock or fire risk**Location:** Basement.**Task:** Have a qualified electrical contractor verify the wiring and associated circuits and confirm that the wiring has been properly disconnected or abandoned.**Time:** As needed.

36. Noted in the home

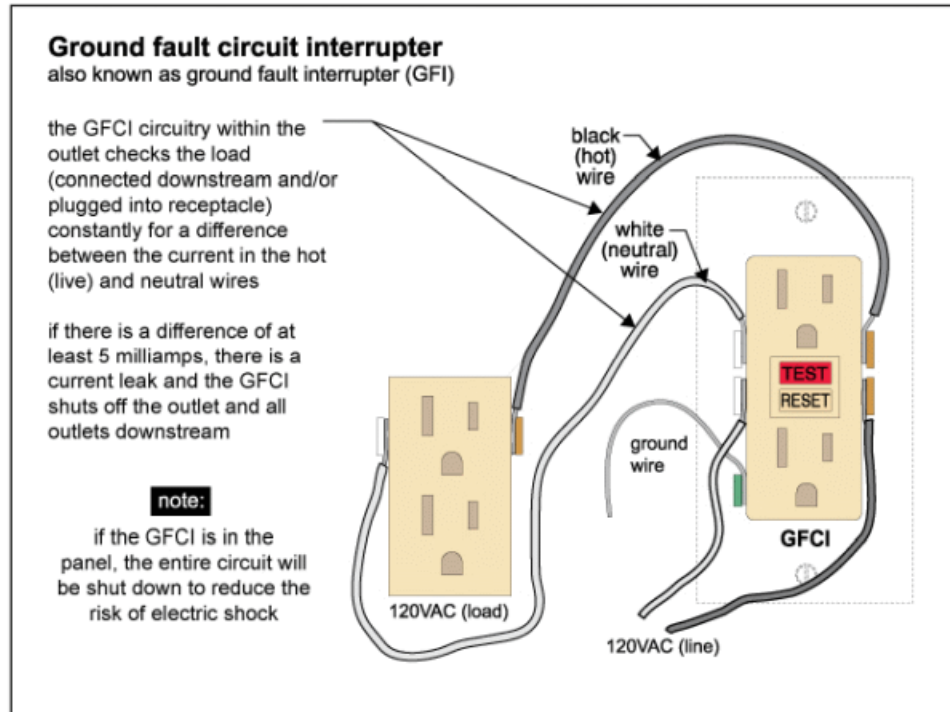
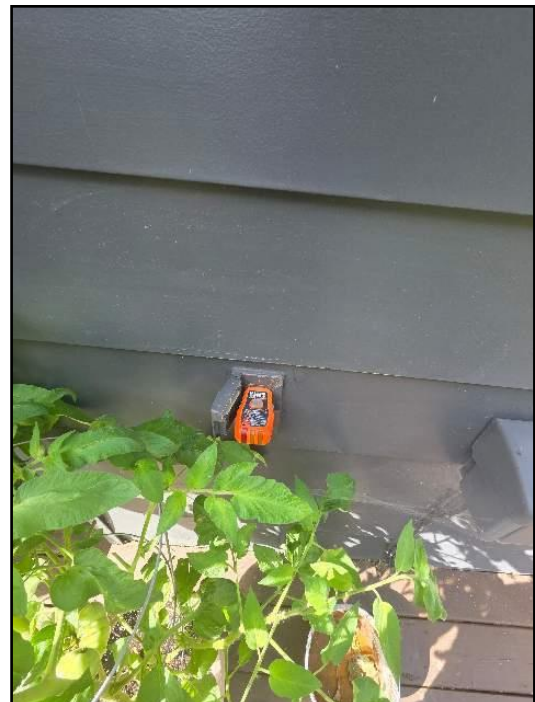
**9. Condition:** • GFCI/GFI needed (Ground Fault Circuit Interrupter)

38. GFCI/GFI needed (Ground Fault Circuit In

**Task:** Install GFCI protection to improve electrical safety.

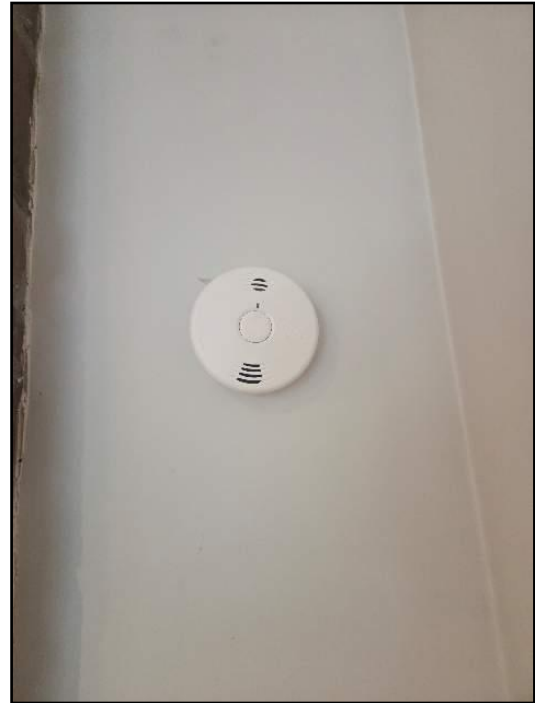
41.

**10. Condition:** • Smoke alarms were missing in several areas of the home.

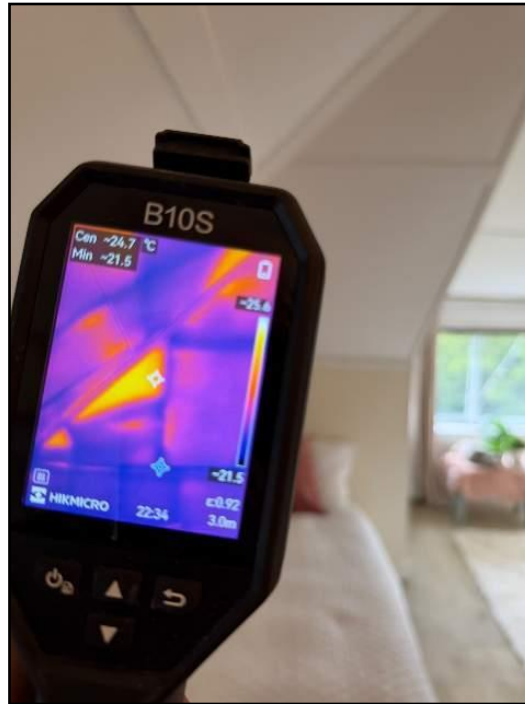
**13. Condition:** • Gaps or voids

52. Gaps or voids

**Task:** Consider improving attic insulation coverage and air sealing where practical to improve energy efficiency.

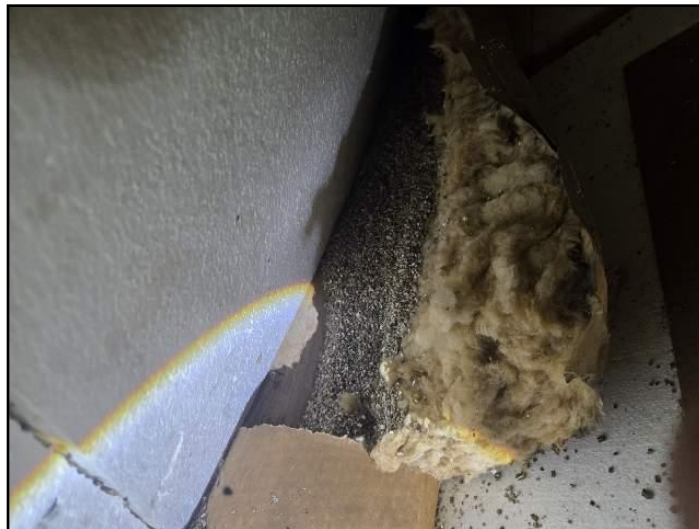
**14. Condition:** • Possible Zonolite (vermiculite)

**Implication(s):** Environmental contamination

53. Possible Zonolite (vermiculite)

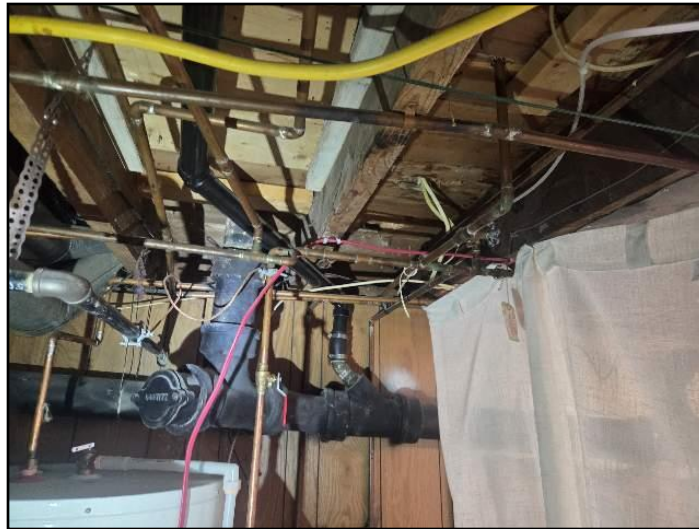
58.

**15. Condition:** • Older cast-iron sewer piping was observed in connection with the home's PVC drainage system. The property is served by a private septic system.

**Implication(s):** The condition of the older cast-iron sewer piping and the septic system could not be fully determined during the inspection. Older buried sewer piping may be susceptible to deterioration or root intrusion.

**Task:** Have the sewer line further evaluated with a camera scope by a qualified plumbing contractor, and have the septic system inspected by a qualified septic professional. Confirm the condition and operation of the septic system and service or pump as recommend

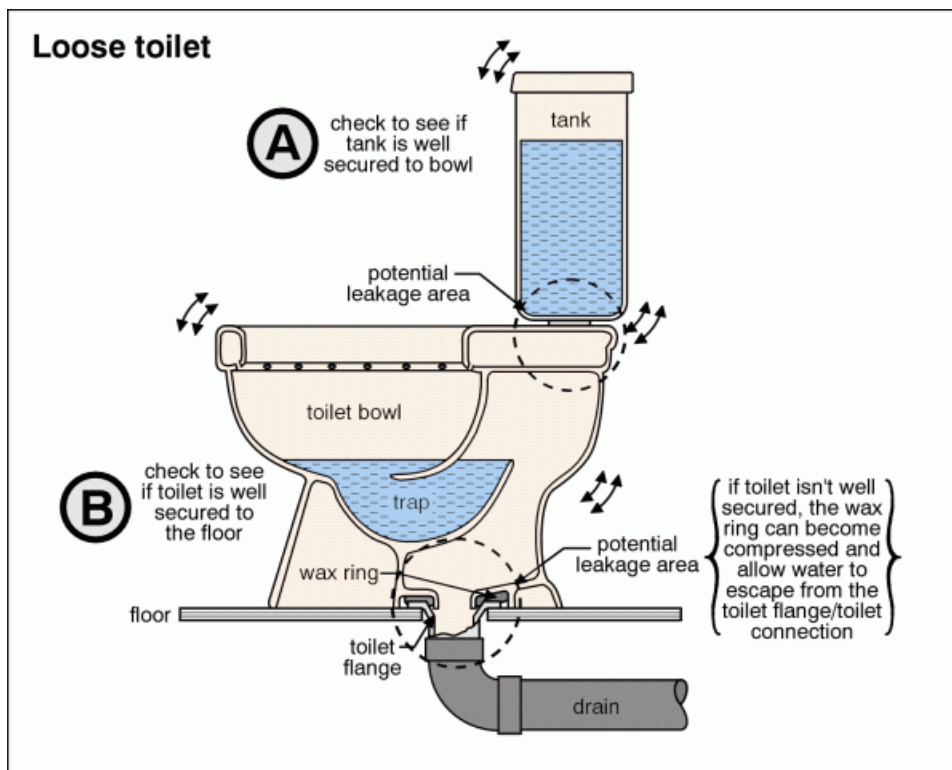
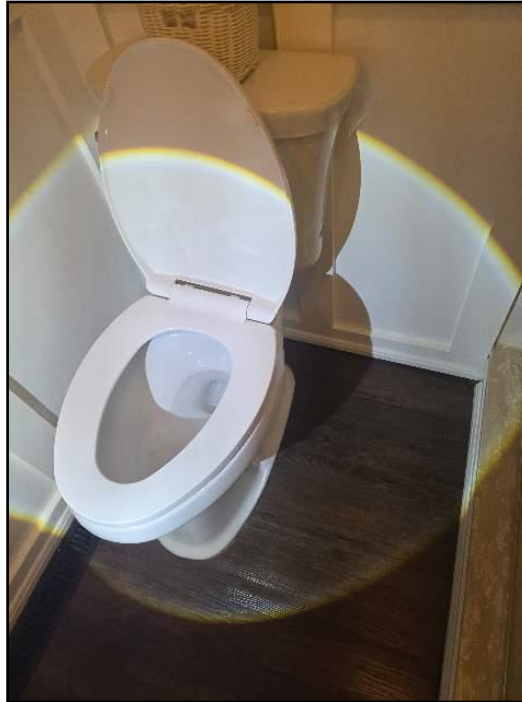
**17. Condition:** • Loose

**Implication(s):** Chance of water damage to structure, finishes and contents | Sewage entering the building | Possible hidden damage

60. Loose

**Task:** Secure the affected component.

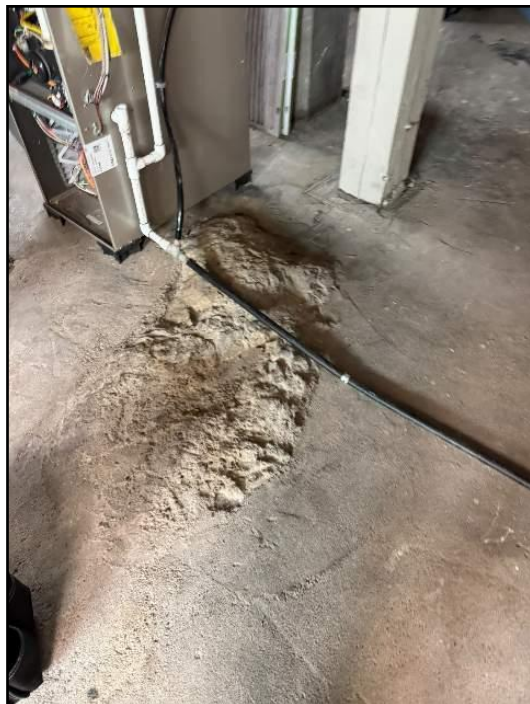
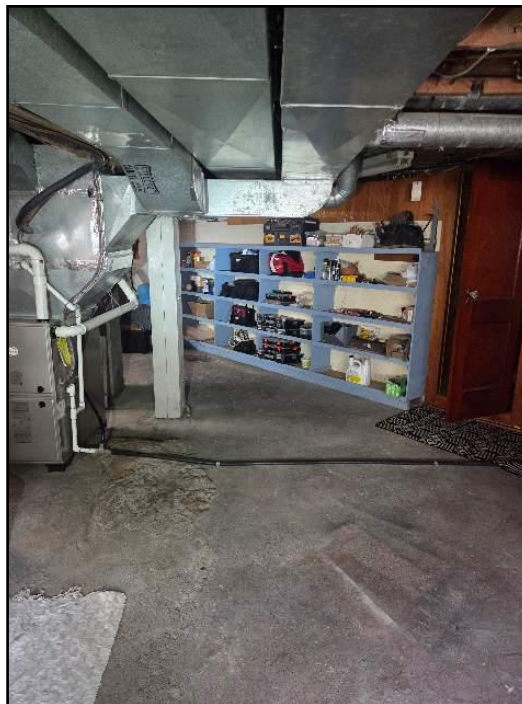
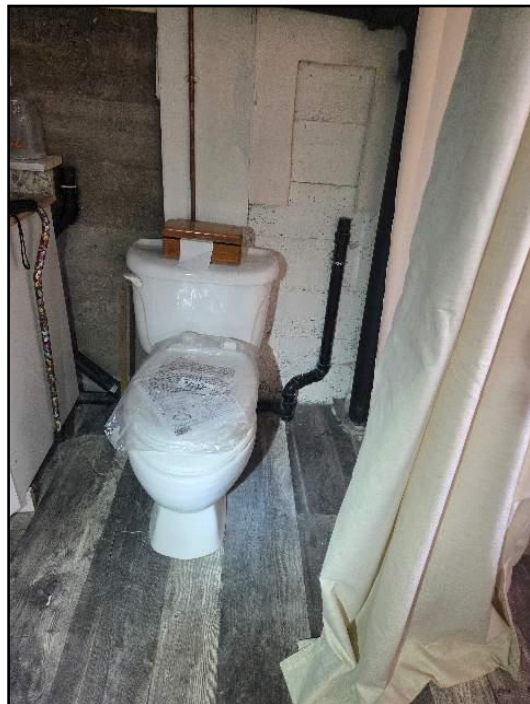
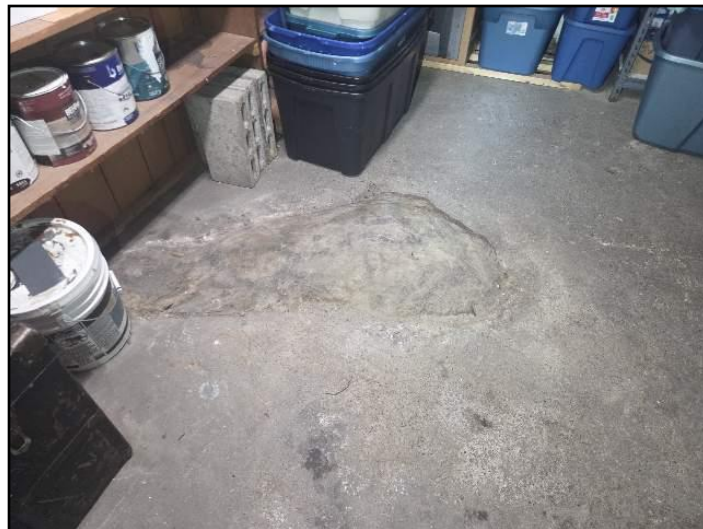
**18. Condition:** • Trip hazard

65. Trip hazard

**Task:** Monitor and repair as needed.

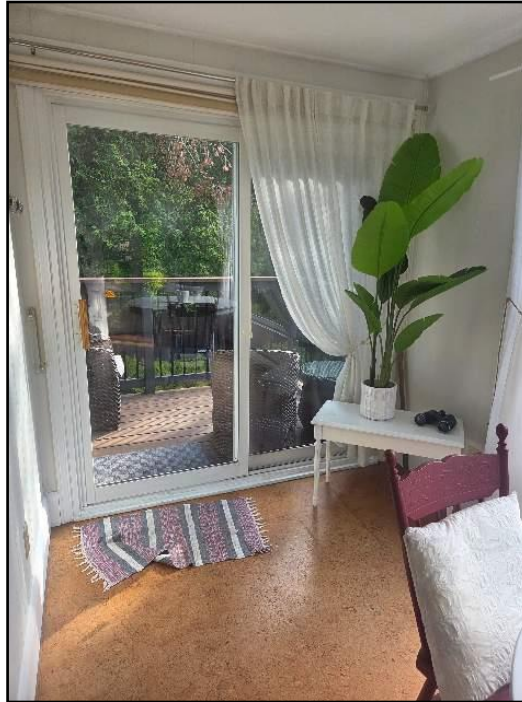
**19. Condition:** • Original lower quality units

69. Original lower quality units

**Task:** Monitor for deterioration and consider replacement as needed to improve energy efficiency.

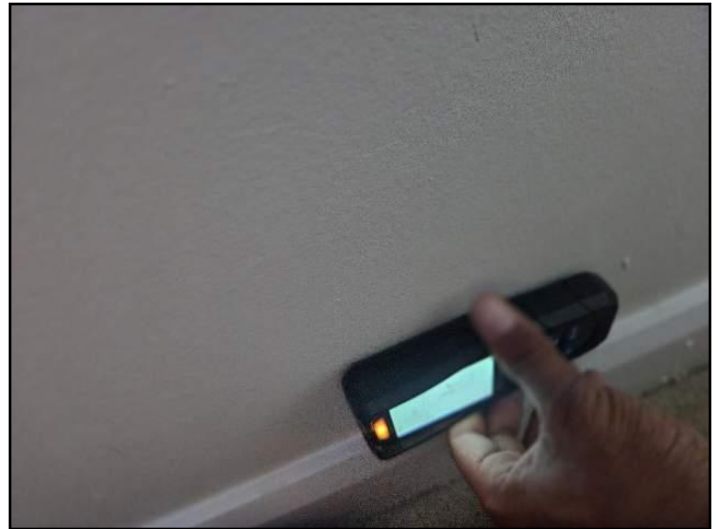
71.

**20. Condition:** • Elevated moisture was observed on the drywall below the bedroom window above living area.

**Task:** Monitor for further moisture or staining and have the window and surrounding area further evaluated and repaired as needed.

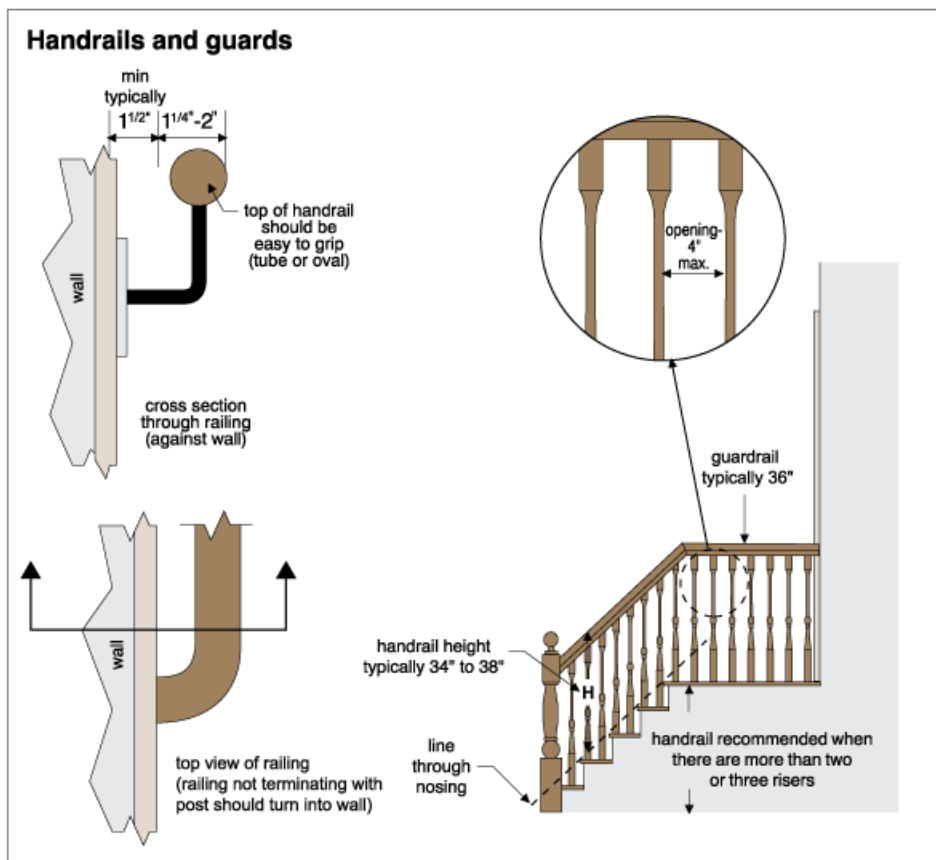
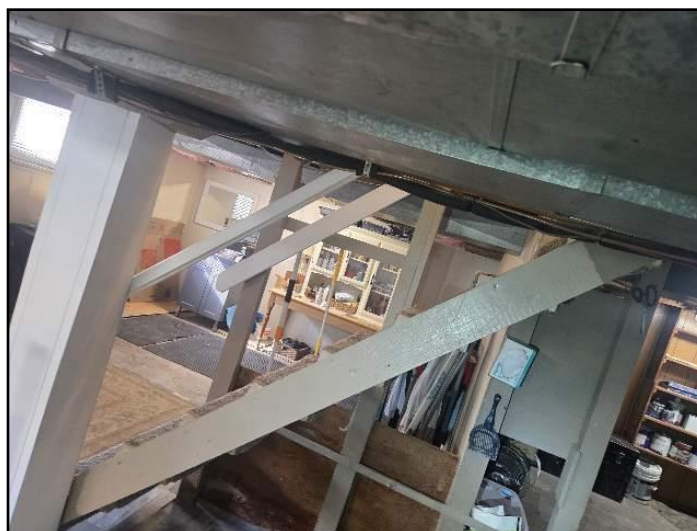
**21. Condition:** • Missing

**Implication(s):** Fall hazard

73. Missing

**Task:** Install balusters to improve safety.

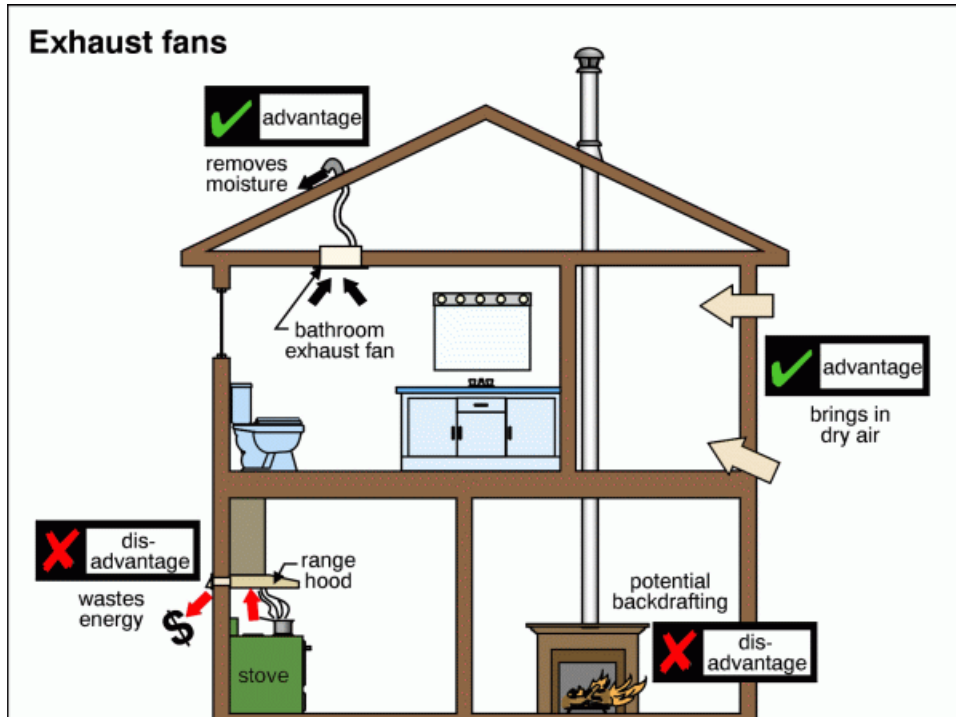
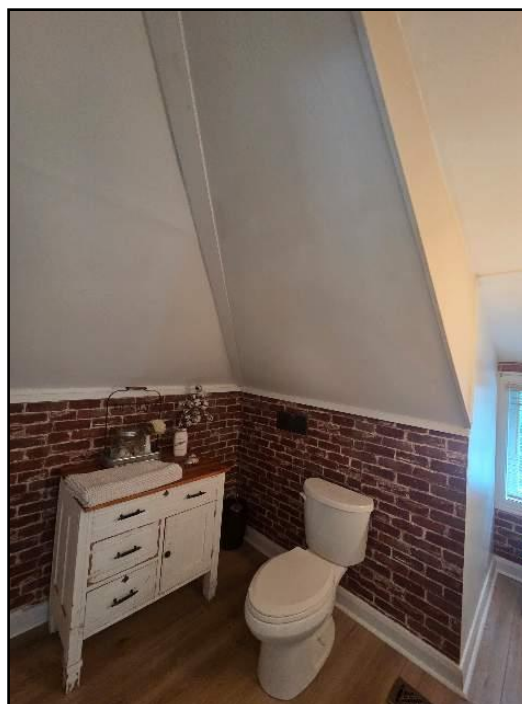
22. Condition: • Missing

Implication(s): Chance of condensation damage to finishes and/or structure

74. Missing

**Task:** Install exhaust fan to improve moisture control.

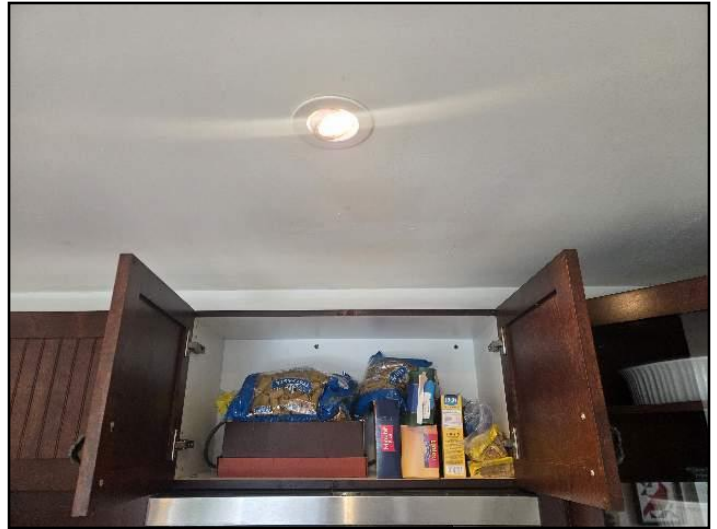
**23. Condition:** • Not vented to exterior

**Implication(s):** Chance of condensation damage to finishes and/or structure

76. Not vented to exterior

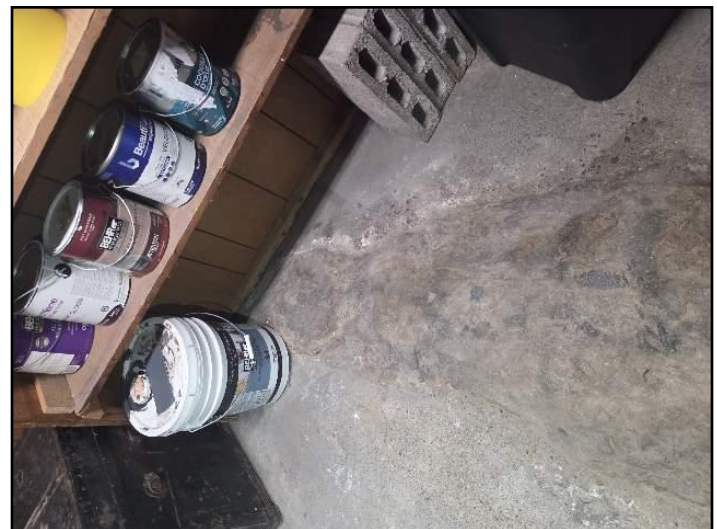
**24. Condition:** • Efflorescence

Efflorescence observed on the basement floor.

**Implication(s):** Chance of water damage to structure, finishes and contents

78. Efflorescence

**Task:** Monitor the area for recurring efflorescence or signs of moisture and maintain proper exterior drainage to help minimize moisture exposure.

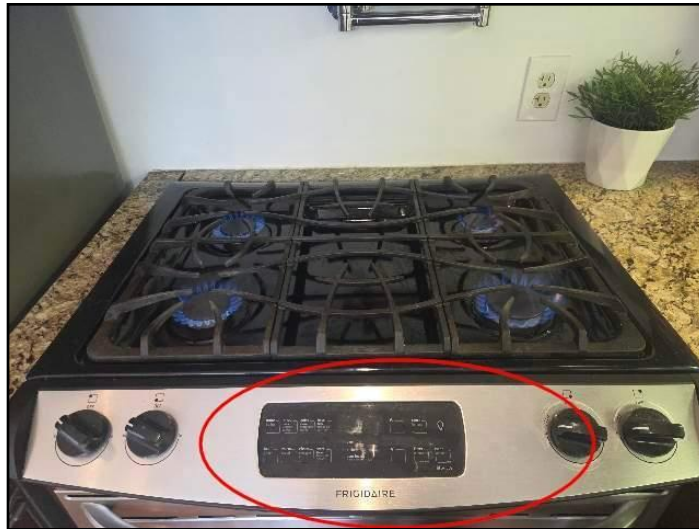
79.

25. Condition: • All four gas burners operated as intended. Oven operation could not be tested because the range oven

light/ignition was not operational. Further evaluation with the seller is recommended.

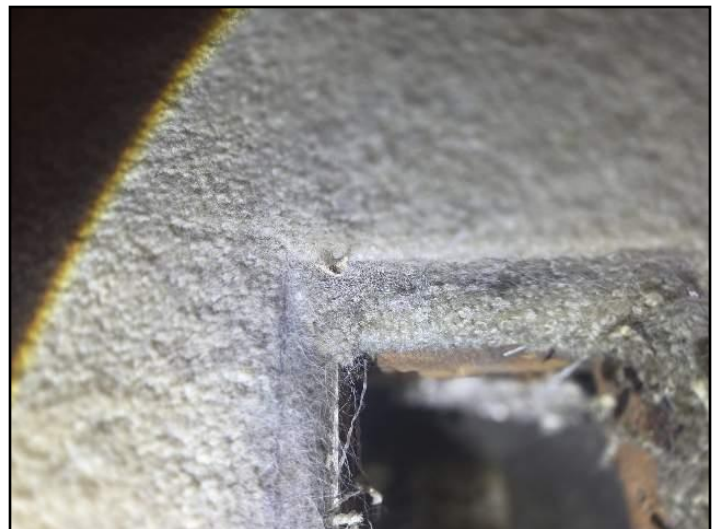
**26. Condition:** • Possible asbestos containing materials

Suspected asbestos-containing material observed around the second-floor heat register.

**Implication(s):** Health hazard

81. Possible asbestos containing materials

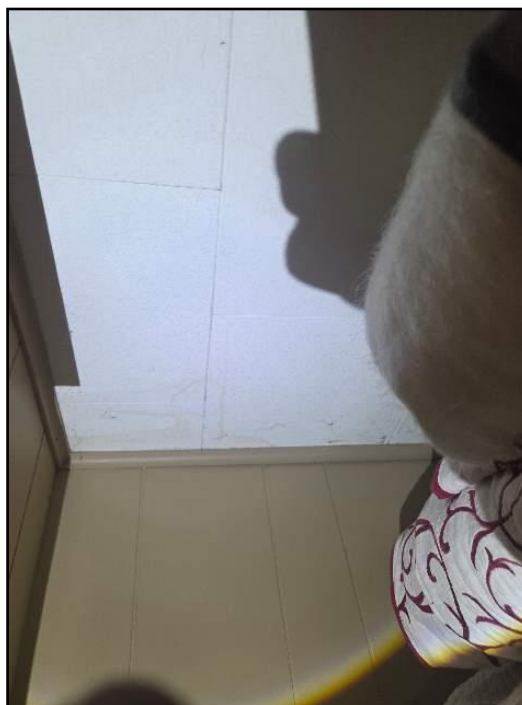
**27. Condition:** • Possible asbestos containing materials

Suspected asbestos-containing materials were observed in various areas, including loose material in the basement, material around the basement HVAC ductwork, and older tiles/material inside a first-floor cupboard.

**Implication(s):** Health hazard

**84.** Possible asbestos containing materials

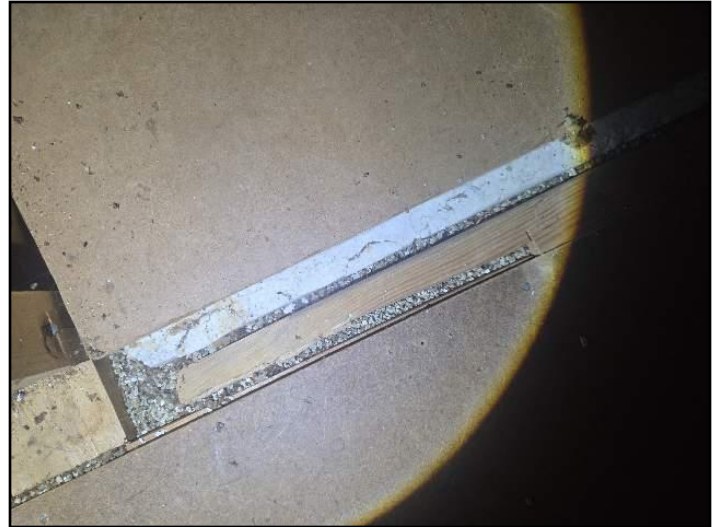
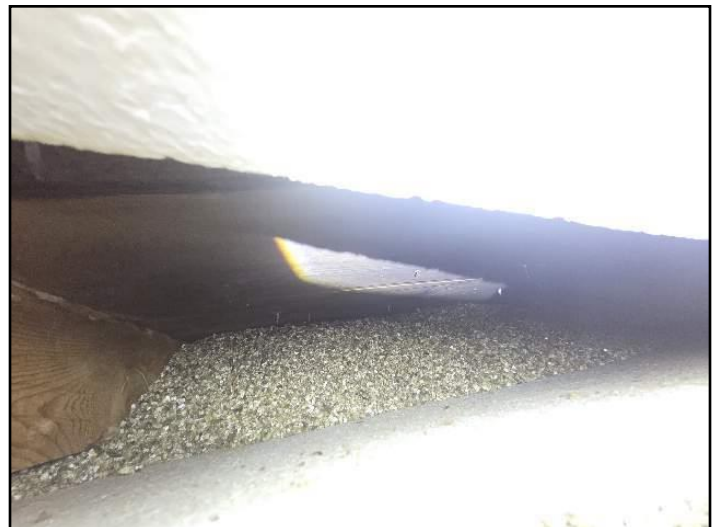
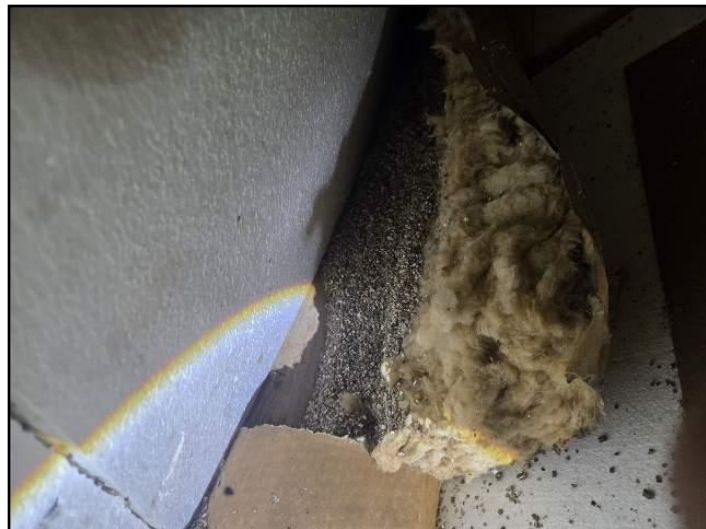
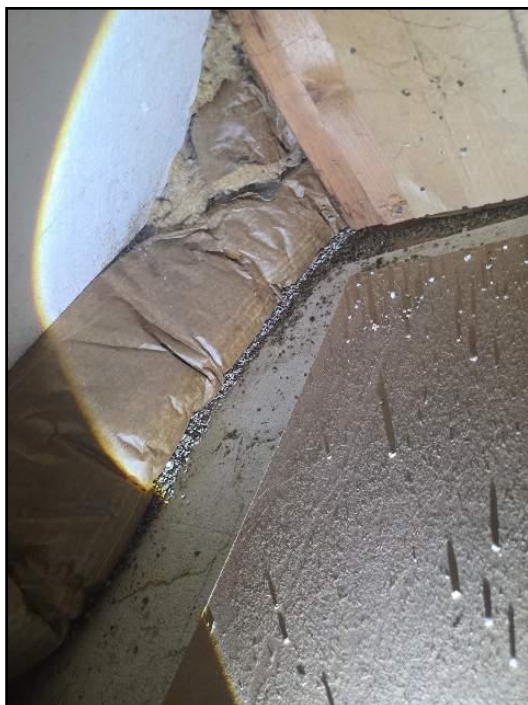
**28. Condition:** • Possible asbestos containing materials

Vermiculite insulation was observed in the attic, suspected to contain asbestos.

**Implication(s):** Health hazard

**86.** Possible asbestos containing materials

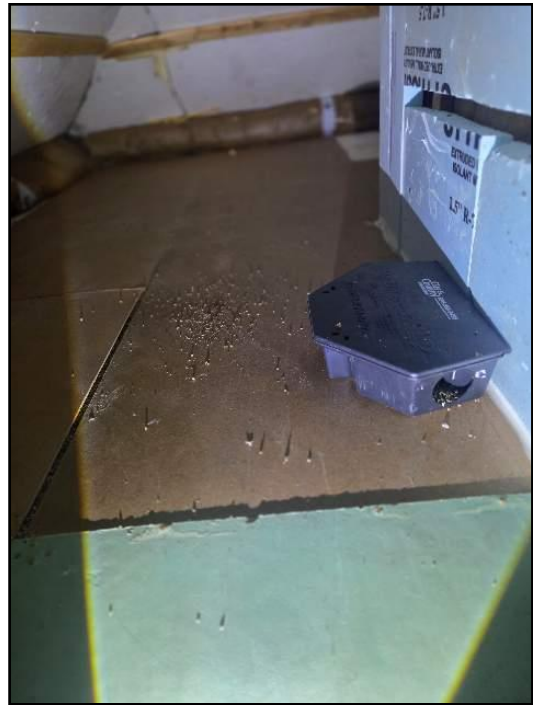
94.

**29. Condition:** • Evidence of previous pest treatment observed in the attic and throughout the house. No active pest activity observed at the time of inspection.
