# SUMMARY

1234 Bay St, My Twin City, ON August 19, 2026

Report No. 1098, v.4

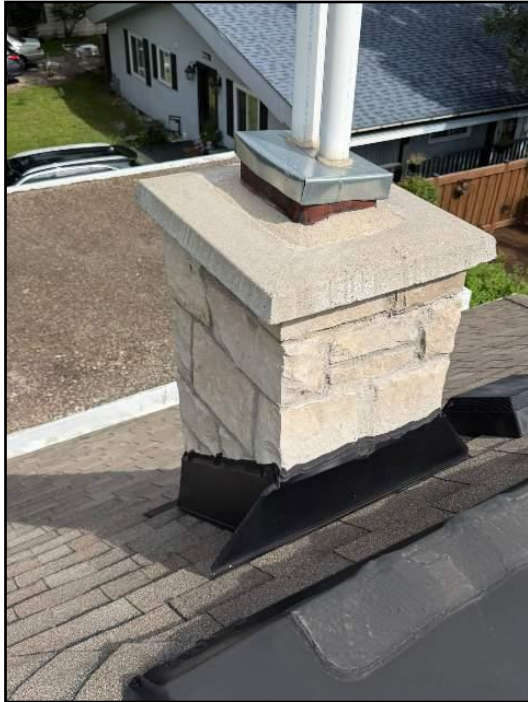
**1. Condition:** • Not let into mortar joints

**Implication(s):** Chance of water damage to structure, finishes and contents

8. Not let into mortar joints

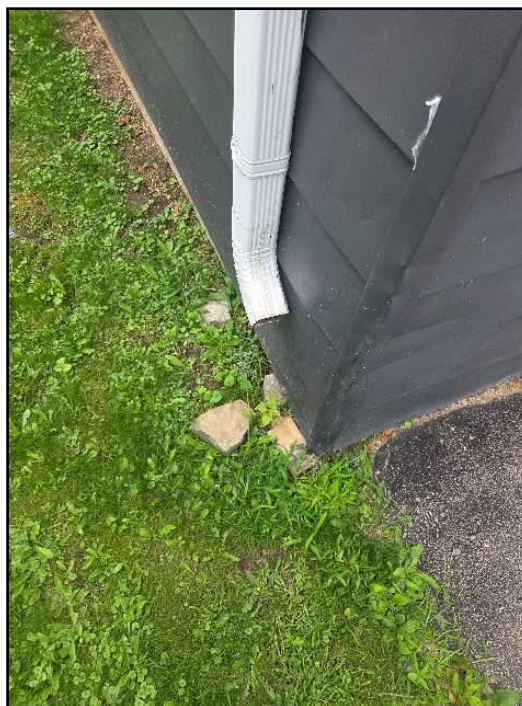
**2. Condition:** • Discharge too close to building

**Implication(s):** Chance of water damage to structure, finishes and contents

10. Discharge too close to building

**Task:** Extend downspouts to direct water away from foundation.

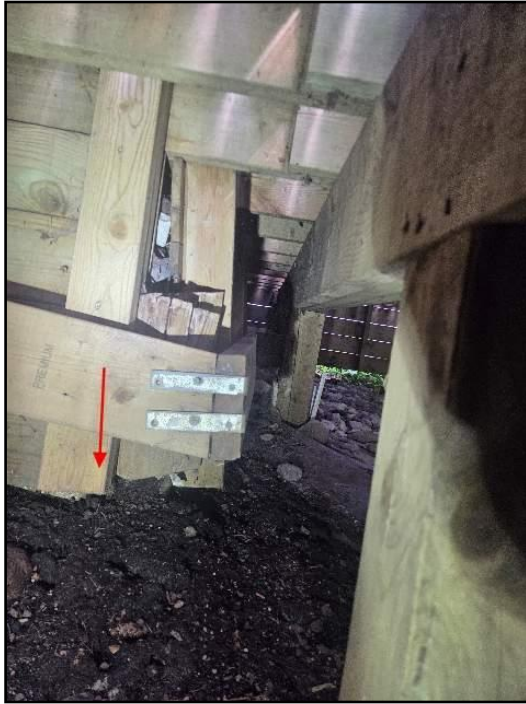
Wood deck support posts were observed in direct contact with soil, with elevated moisture noted around portions of the support structure.

**Implication(s):** Weakened structure | Chance of movement | Rot | Insect damage

13. Wood/soil contact

**Task:** Improve drainage and separate the wood posts from direct soil contact where possible. Monitor the affected areas for moisture, decay, and premature wood deterioration.

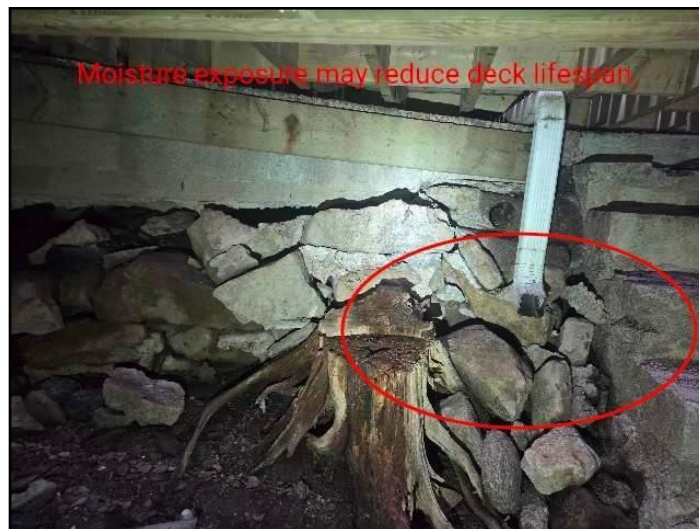
15. Wood/soil contact

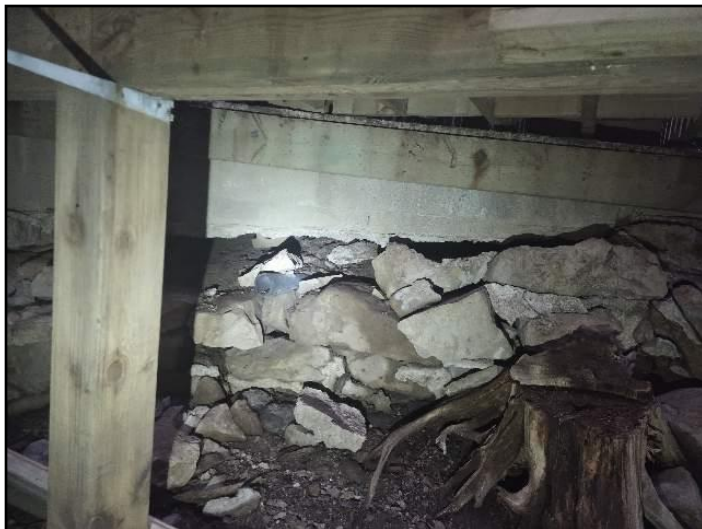
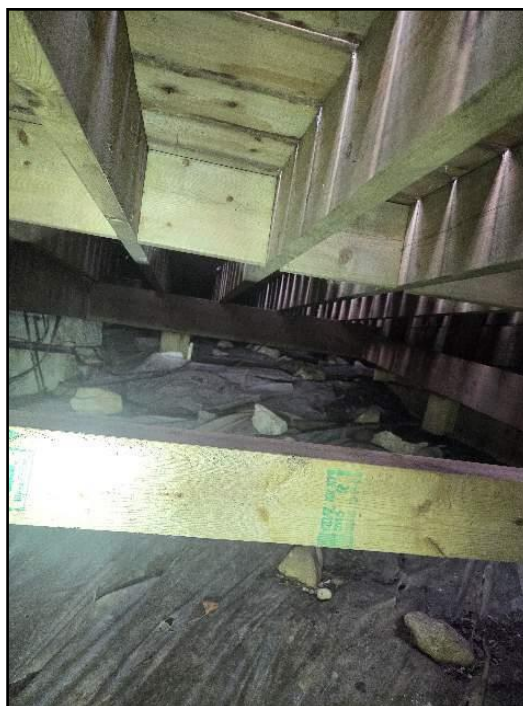
**4. Condition:** • Localized displacement and deterioration observed in the stone/concrete retaining area, with some stress noted at adjacent wood framing.

**Task:** Monitor the area for further movement and have the affected area further evaluated and repaired or stabilized as needed.

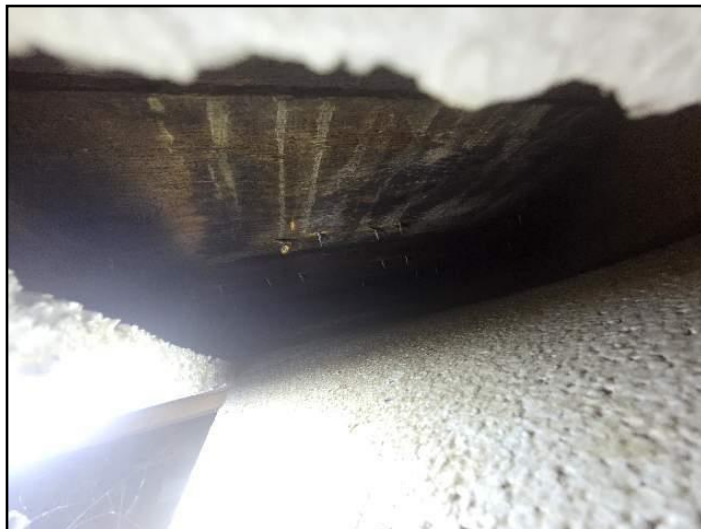
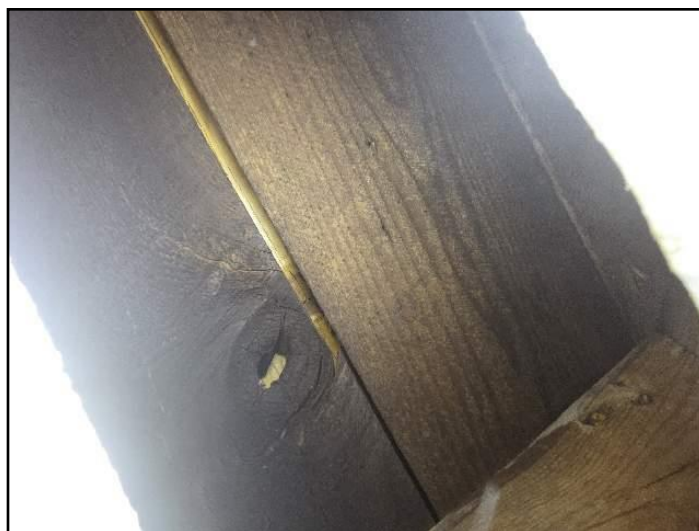
**6. Condition:** • Staining and discoloration observed on portions of the attic roof framing. Portions of the framing were covered with foam insulation.

**Task:** Have the attic framing and roof area further evaluated by a qualified roofing contractor and repair as needed.

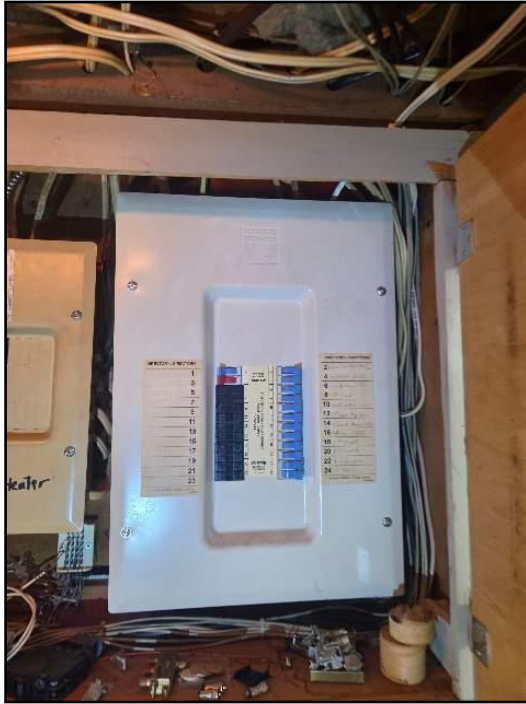
34.

**7. Condition:** • Federal Pioneer Stab-Lok electrical panel and breakers observed.

**Implication(s):** Certain Stab-Lok circuit breakers have been subject to safety recalls due to the potential for breakers to fail to trip under fault conditions, increasing the risk of overheating or fire.

**Task:** Have the panel and breakers further evaluated by a qualified electrical contractor. Replacement of the panel should be considered based on the evaluation and condition of the equipment.

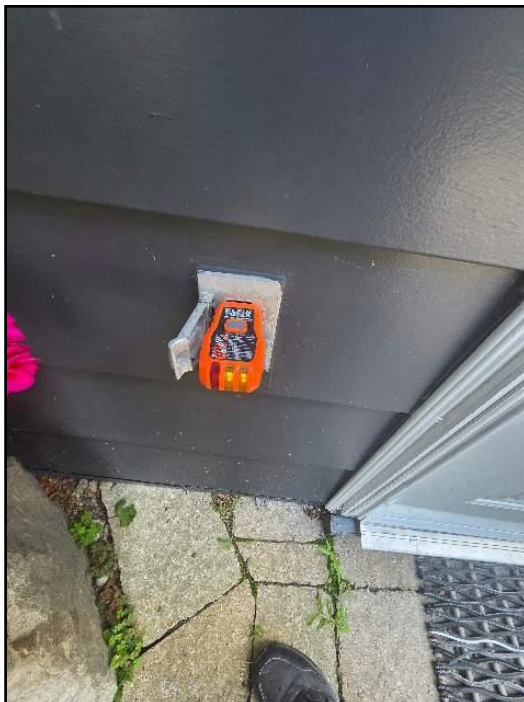
**9. Condition:** • GFCI/GFI needed (Ground Fault Circuit Interrupter)

38. GFCI/GFI needed (Ground Fault Circuit In

**Task:** Install GFCI protection to improve electrical safety.

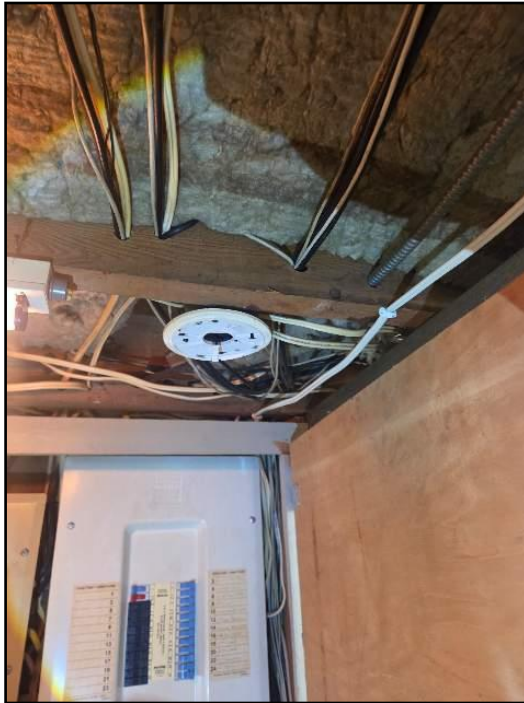
40.

**10. Condition:** • Smoke alarms were missing in several areas of the home.

**Task:** Install additional smoke alarms as required. Consider installing interconnected combination smoke/CO alarms throughout the home for improved safety.

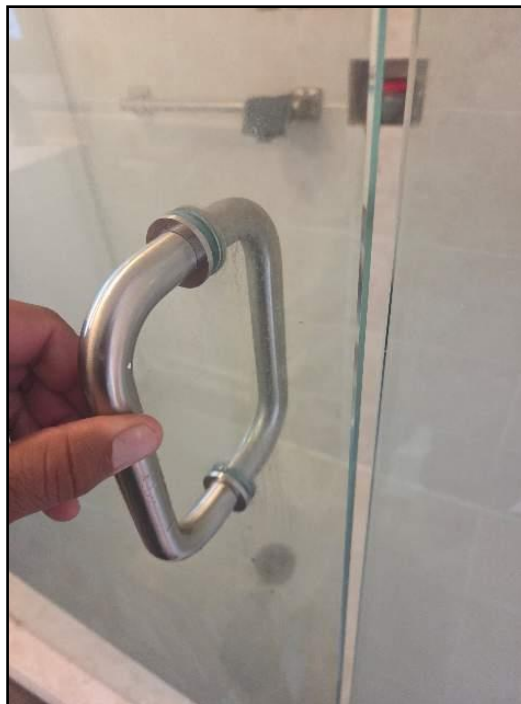
59.

**16. Condition:** • Shower door handle was loose

**Task:** Secure the shower door handle.

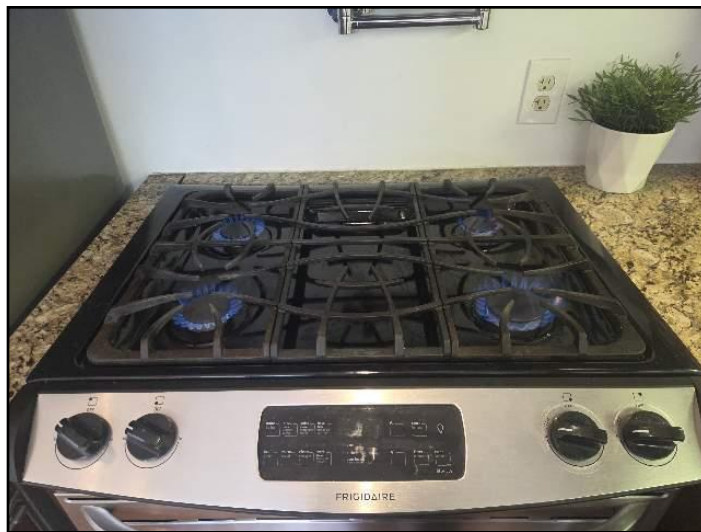
Operated and observed working at the time of inspection.

64. Range

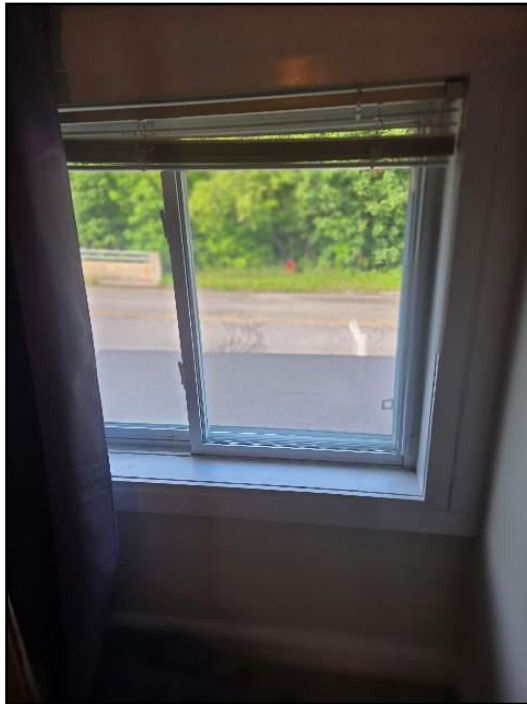
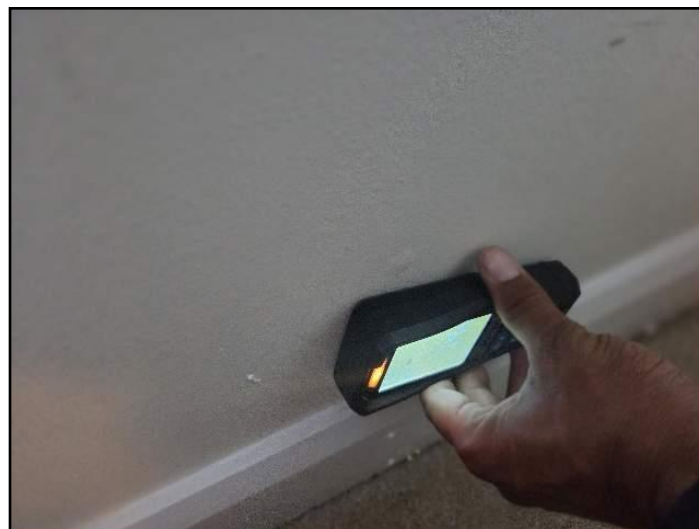
70.

**20. Condition:** • Elevated moisture was observed on the drywall below the bedroom window above living area.

**Task:** Monitor for further moisture or staining and have the window and surrounding area further evaluated and repaired as needed.

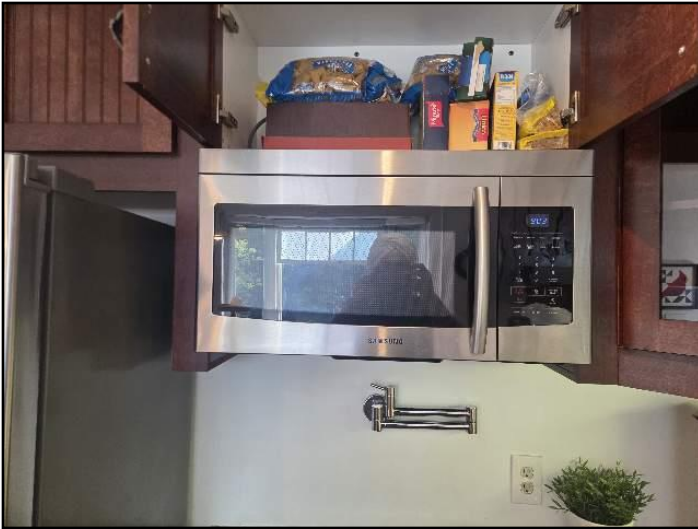
**23. Condition:** • Not vented to exterior

**Implication(s):** Chance of condensation damage to finishes and/or structure

75. Not vented to exterior

**Task:** Consider providing exterior ventilation for the range hood.

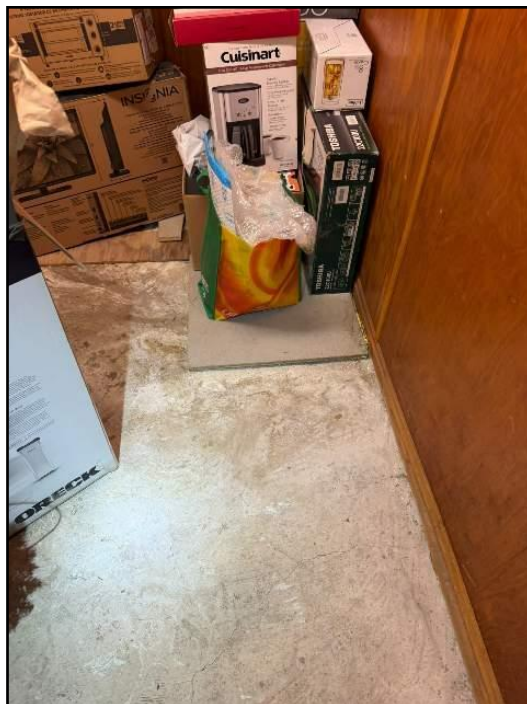
**24. Condition:** • Efflorescence

Efflorescence observed on the basement floor.

**Implication(s):** Chance of water damage to structure, finishes and contents

77. Efflorescence

**Task:** Monitor the area for recurring efflorescence or signs of moisture and maintain proper exterior drainage to help minimize moisture exposure.

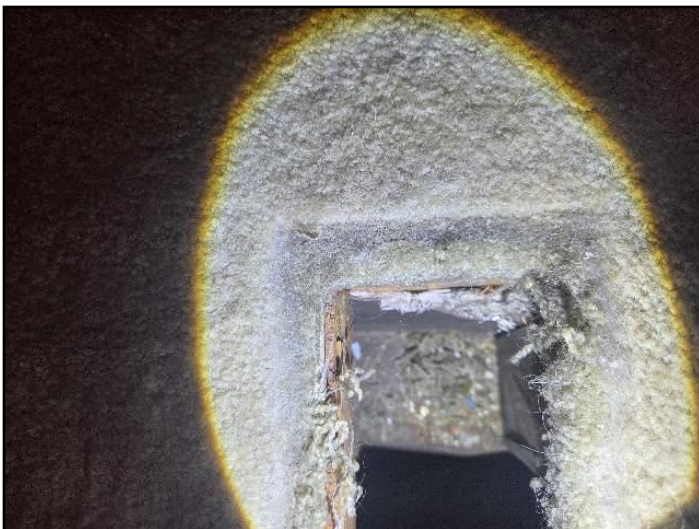
**26. Condition:** • Possible asbestos containing materials

Suspected asbestos-containing material observed around the second-floor heat register.

**Implication(s):** Health hazard

80. Possible asbestos containing materials

**Task:** Have the material further evaluated and tested by a qualified asbestos professional. If asbestos is confirmed, have it appropriately managed, encapsulated, or removed by qualified professionals.

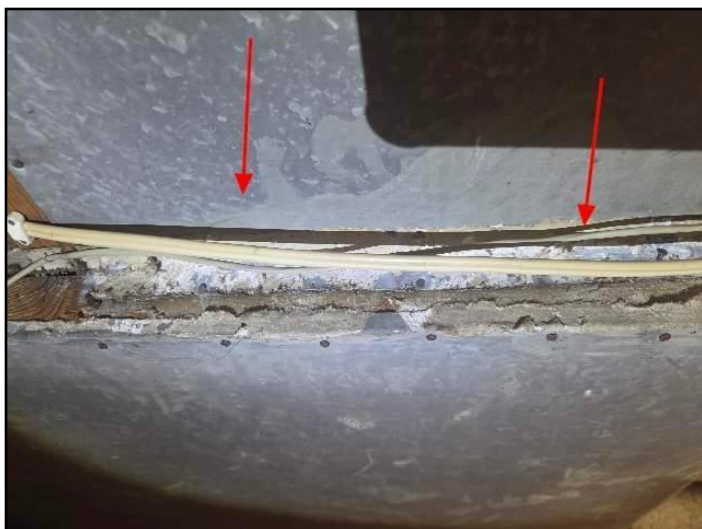
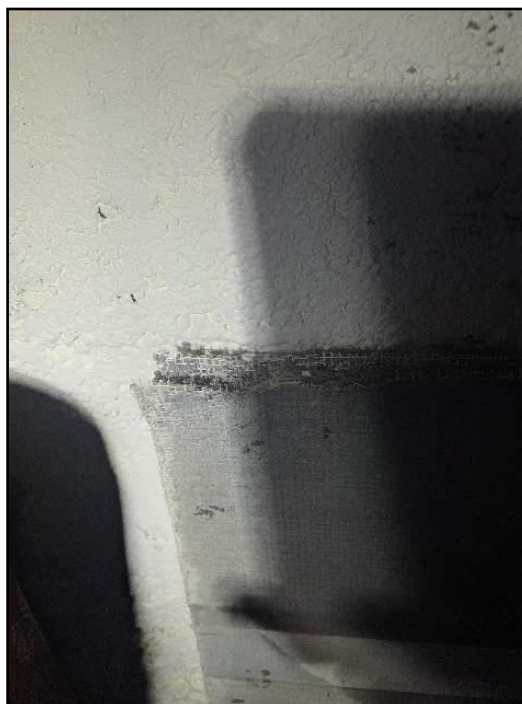
**27. Condition:** • Possible asbestos containing materials

Suspected asbestos-containing materials were observed in various areas, including loose material in the basement, material around the basement HVAC ductwork, and older tiles/material inside a first-floor cupboard.

**Implication(s):** Health hazard

82. Possible asbestos containing materials

83. Possible asbestos containing materials

**Task:** Have the identified materials further evaluated and tested by a qualified asbestos professional. Avoid disturbing, removing, or disposing of the materials until their composition has been determined. If asbestos is confirmed, have the materials appropriate

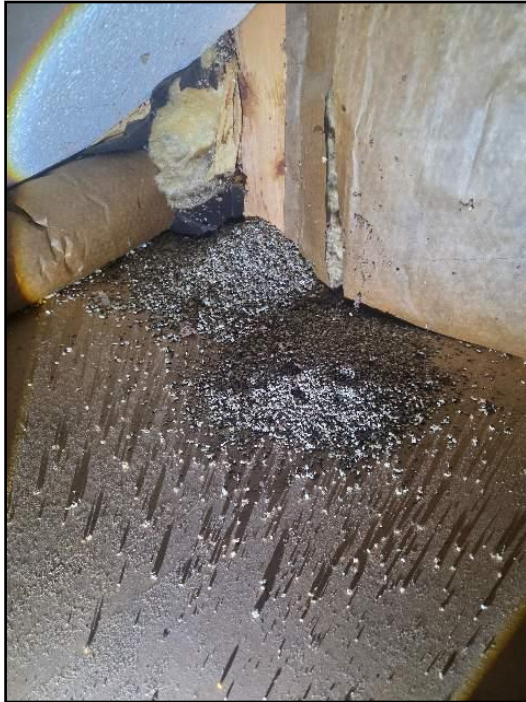
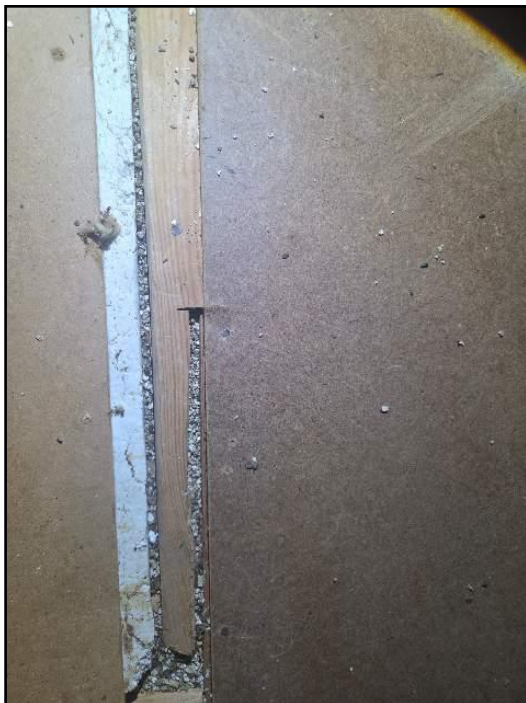
**28. Condition:** • Possible asbestos containing materials

Vermiculite insulation was observed in the attic, suspected to contain asbestos.

**Implication(s):** Health hazard

**85.** Possible asbestos containing materials

**87.** Possible asbestos containing materials

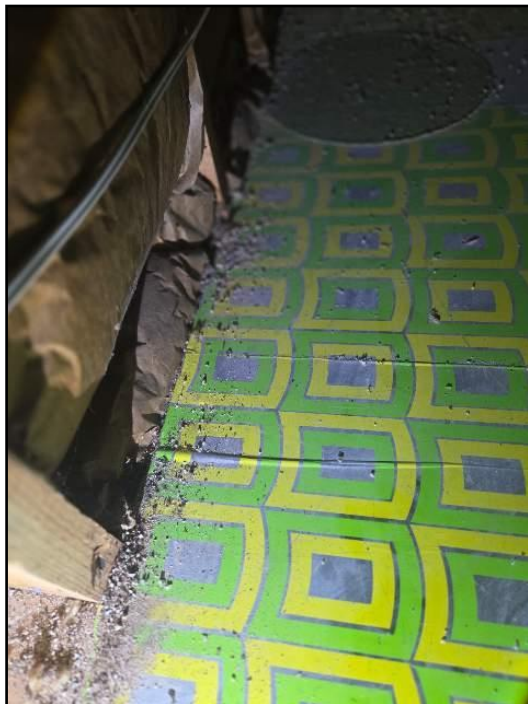
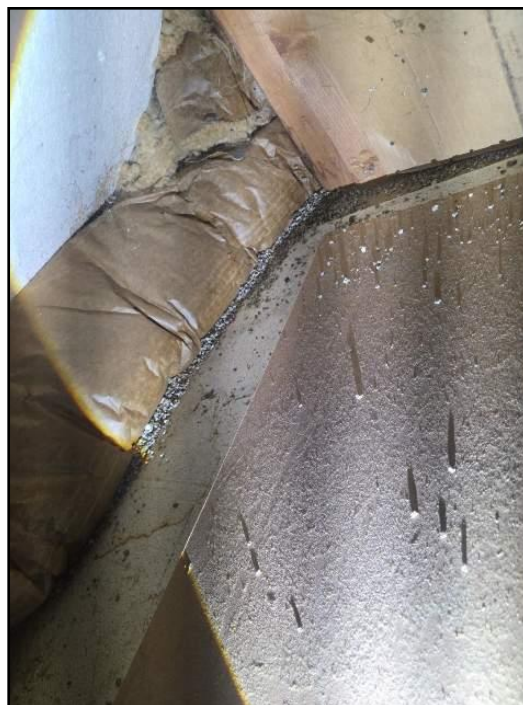
89. Possible asbestos containing materials

92. Possible asbestos containing materials

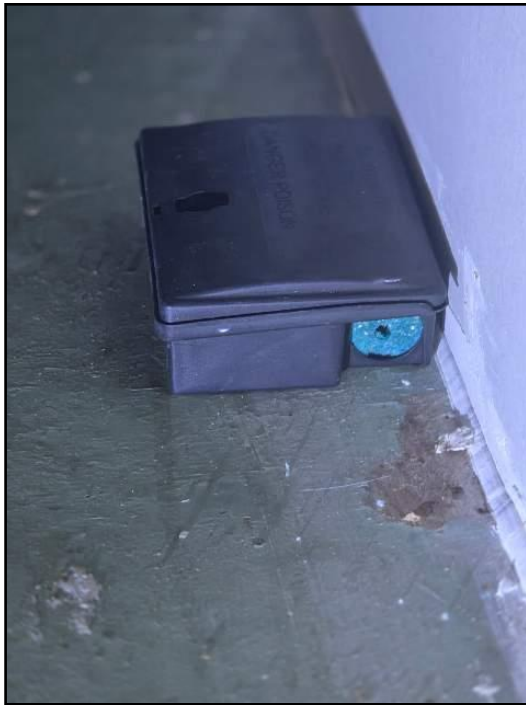
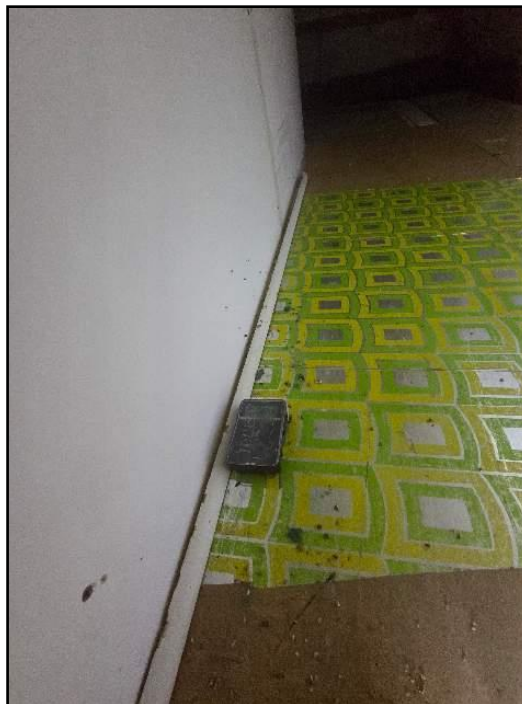
93.

**29. Condition:** • Evidence of previous pest treatment observed in the attic and throughout the house. No active pest activity observed at the time of inspection.

**Task:** Monitor for signs of pest activity and obtain previous treatment information as available.
